# Service Technical Information

| MODEL NO. | XR-MD85 EZ |
| SUBJECT | Tape stop at FM recording |

REF.No. :G - 99 - 047 - E0

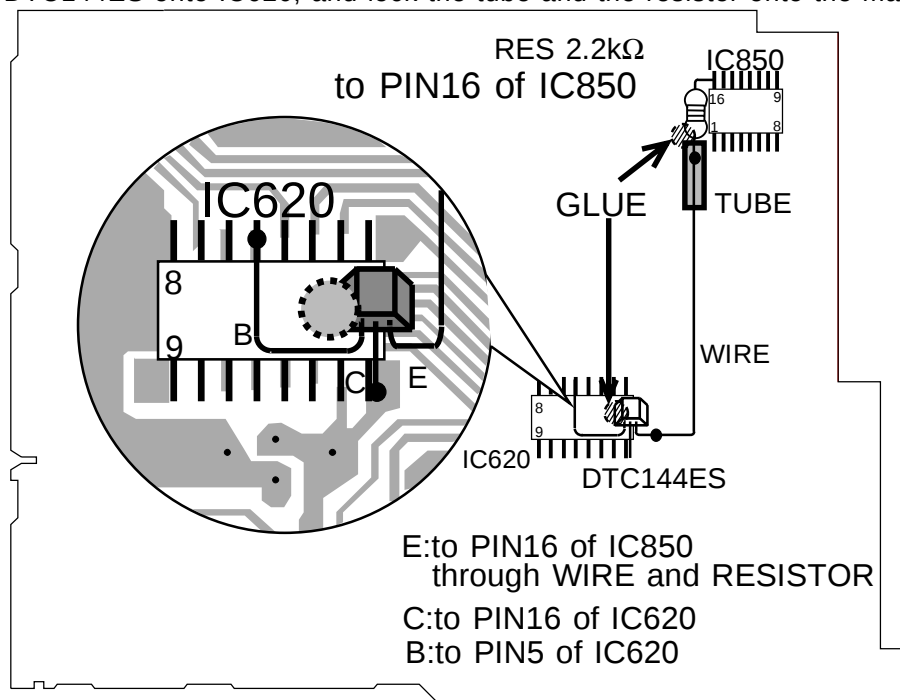
## MAIN C.B. PATTERN SIDE

A tape stops in approximately 5 minutes after starting recording of an FM program on tape, using the model in question.

This problem occurs when an FM signal includes RDS signal.

1. Solder the base terminal of DTC144ES to pin 5 on IC620, and solder the collector terminal of DTC144ES to pin 16 of IC620.
2. Solder the emitter terminal of DTC 144ES to the wire, and let the wire in the tube.
3. Solder an end of the wire to the resistor.  
Solder the other end of the resistor to pin 16 of IC850.
4. Lock DTC144ES onto IC620, and lock the tube and the resistor onto the main C.B. with glue.
