# Service Technical Information

| MODEL NO. | XR-MD90 EZ |
| SUBJECT | Noise at tuner function |

REF.No. :G - 99 - 055 - E0

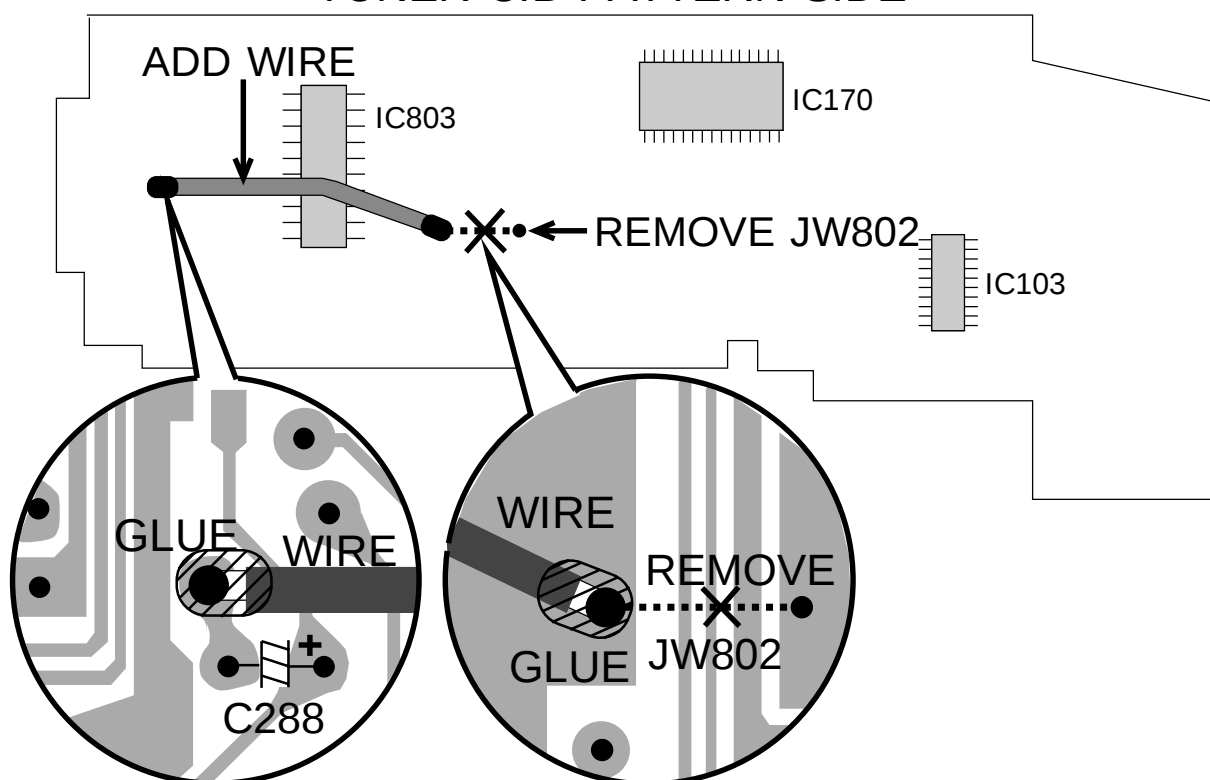
## TUNER C.B PATTERN SIDE

A high-frequency noise is heard with a volume at "0" position in the tuner function mode.  
Take the following actions if the problem occurs.

1. Remove CABI, TOP AMP in the amplifier block.
2. Remove the JW802 tuner C.B..
3. Solder the wire onto a JW802 pin (one connected to pin 5 of IC803).
4. Solder the other side wire onto a digital ground (minus pin of C288).
5. Lock the both end of the wire with glue.
