# Service Technical Information

| MODEL NO. | AM-F70 / F65 |
| SUBJECT | "Caution!" display appears. |

REF.No. :G - 99 - 019 - E0

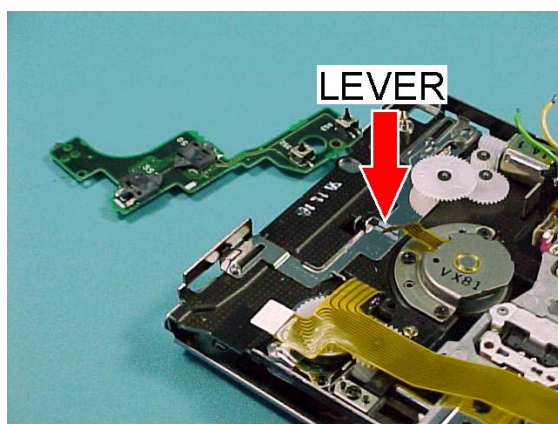
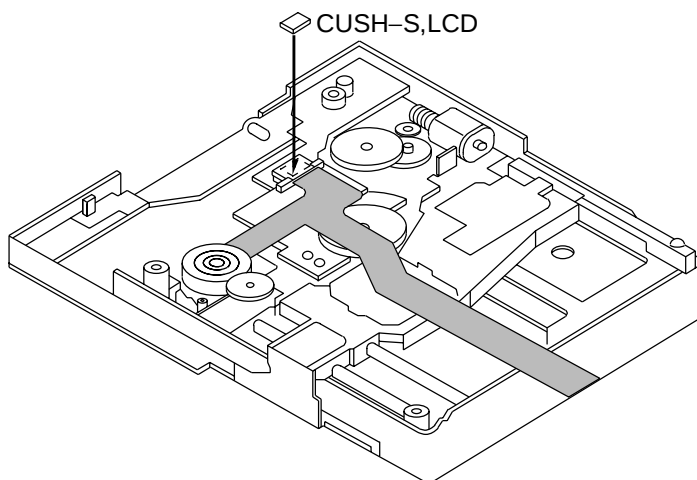
Fig. 1

This symptom occurs when  $\mu$ -COM fails to detect on/off of OWH UP(S50)/DOWN(S51) SW.

- If on/off detect of a switch fails even though the OWH position detect switch is pressed:  
Replace the detection switch with new one.
- If the lever runs on to OWH UP SW(S50) (See Fig.1):  
Remove the lever away from the switch, and then affix a cushion (CUSH-S, LCD) on to the connector of PWB, MECH (CN50).

If that is the case, replace the two switches, S50 and S51 with new ones.
